Final Report No. 2370

by the Swiss Transportation Safety Investigation Board STSB

on the accident involving
the Junkers Ju 52/3m g4e
commercial aircraft, HB-HOT,

on 4 August 2018

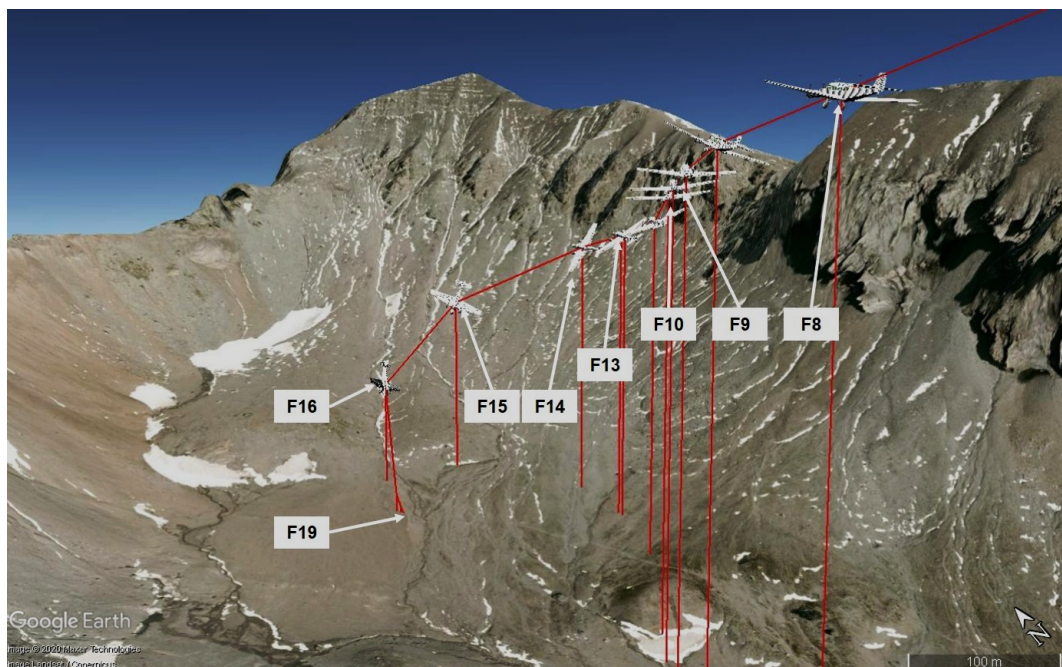
At the same time, the pitch attitude began to decrease and the flight path ran increasingly steeper downwards whilst the left bank attitude constantly increased (see figure 6).

Figure 6: Photogrammetrically reconstructed flight path of HB-HOT on 4 August 2018 (red) between point F8 and the site of the accident (F19), with Piz Segnas in the background; shown on Google Earth. The aircraft has been enlarged by a factor of 2.5 to make it easier to see.

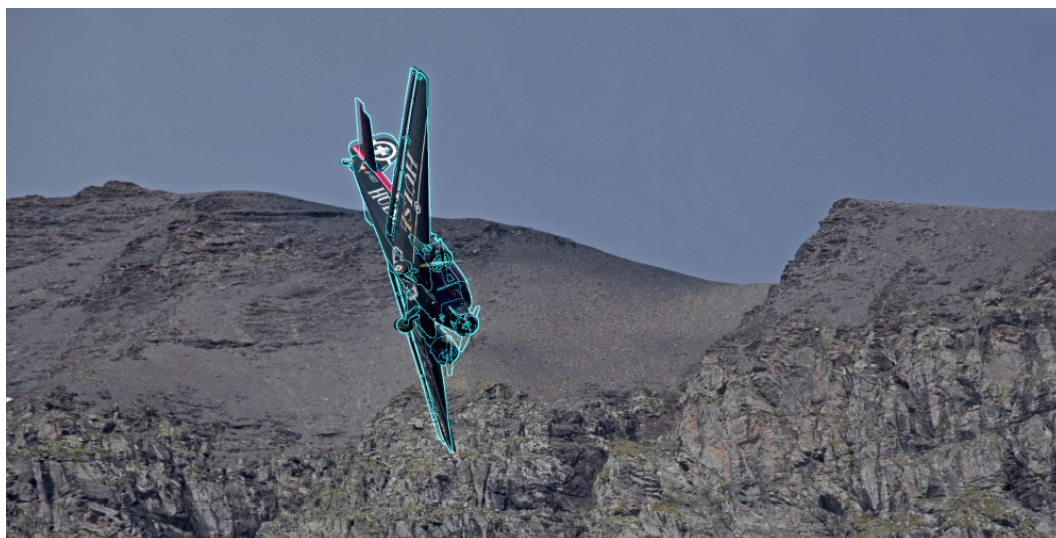
and 7), its longitudinal axis was pointing downwards by 68 degrees from horizontal. By this time, the elevator had deflected upwards by approximately 13 degrees and the rudder was pointing 2 degrees to the right.

Figure 7: Image showing HB-HOT at point F16, including a superimposed three-dimensional model of an identical Ju 53/3m g4e (light blue) for the purpose of determining attitudes, wing deflection and deflections of the control surfaces. The direction of view is north-eastwards, the southern spur of Piz Segnas is visible in the background.

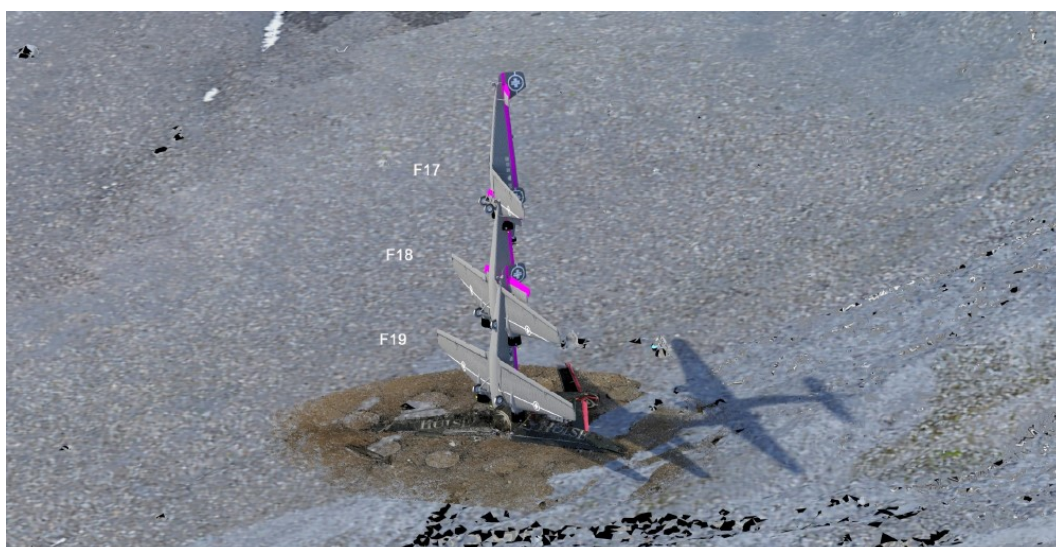
The roll to the left accelerated significantly during this phase. Shortly after 16:57, the aircraft hit the ground in a vertical flight attitude with an almost vertical flight path and at a speed of approximately 200 km/h (see figure 8).

Figure 8: Reconstructed spatial positions and flight attitudes of HB-HOT before impact at points F17, F18 and F19. The three-dimensional model of an identical Ju 52/3m g4e is shown in the reconstructed 3D terrain model with a direction of view to the north. The final position of the wreckage and debris were left vague for a better overview. All 20 people on board the aircraft lost their lives in the accident. The aircraft was destroyed. Fire did not break out.

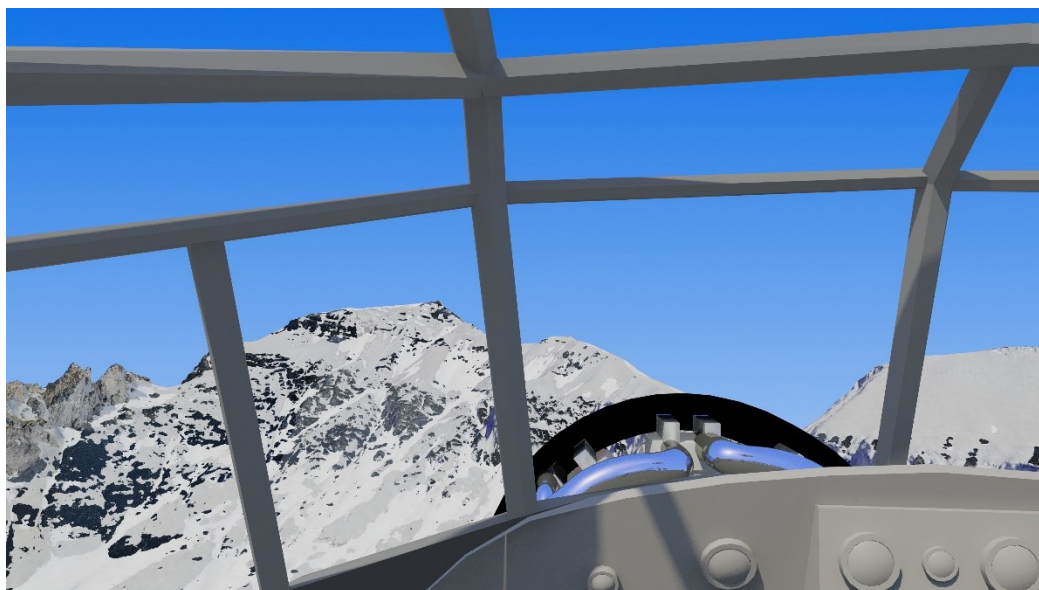
It is conceivable that due to their preoccupation with the engines and the view from the cockpit, which made it difficult to easily recognise the descent, the flight crew's increase in pitch attitude was made subconsciously in order to compensate for this (see figure 21). Furthermore, the fact that the centre of gravity was beyond the rear limit facilitated the process and made the aircraft more unstable around its pitch axis, which represents a factor that directly contributed to the accident.

Figure 21: Reconstructed view from the position of the commander of HB-HOT at point F9. Piz Segnas can be seen in the line of sight. Shown using a simplified model of the aircraft and the three-dimensional terrain model. The absence of visible reference points made it difficult to detect the descent caused by the downdraught.

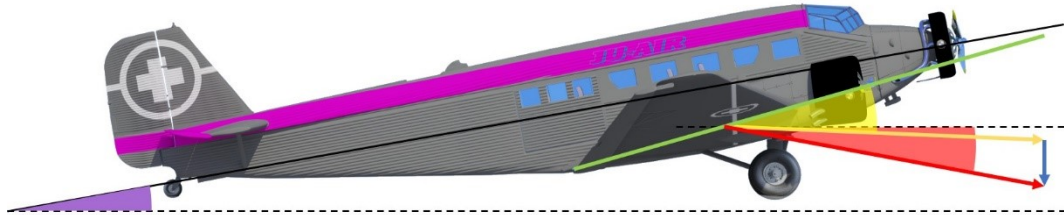
From an aerodynamic point of view, the stall can be explained as follows: HB-HOT had been caused to enter a descent by an area of downdraught. The descent in the downdraught, which was partially compensated by increasing the pitch attitude, led to a flight attitude close to the maximum angle of attack. Given this flight attitude, the additional increase in the angle of attack caused when flying into an updraught was sufficient to lead the airflow to at least partially stall. This development would not have been expected had the downdraught continued or eased slowly. The air currents observed in the basin indicate that the aircraft was moving from an area of downdraught into an area of updraught. A change in the vertical component of the wind's vector from a downdraught with a speed of 2 to 5 m/s to an updraught with a speed of 0 to 3 m/s was sufficient to exceed the critical angle of attack (see figures 22 and 23). As both the measurements and the airflow calculation have shown, even larger shear values were easily possible. Correspondingly turbulent conditions in the mountains are not unusual and become a risk when flying close to the terrain.

Figure 22: Stationary flight in an area of downdraught. Black line: longitudinal axis of the aircraft; Black dashed line: horizontal plane; Green line: chord line; Yellow vector: movement for the aircraft in relation to the area of downdraught; Blue vector: downdraught vector; Red vector: flight path (i.e. the resulting vector of movement for the aircraft in space); Purple angle: pitch angle (angle between the horizontal plane and the aircraft's longitudinal axis); Red angle: flight path angle (angle between the horizontal plane and the flight path); Yellow angle: angle of attack (angle between the direction of airflow, which is the inverse of the vector of movement for the aircraft in relation to the area of downdraught, and the chord line).

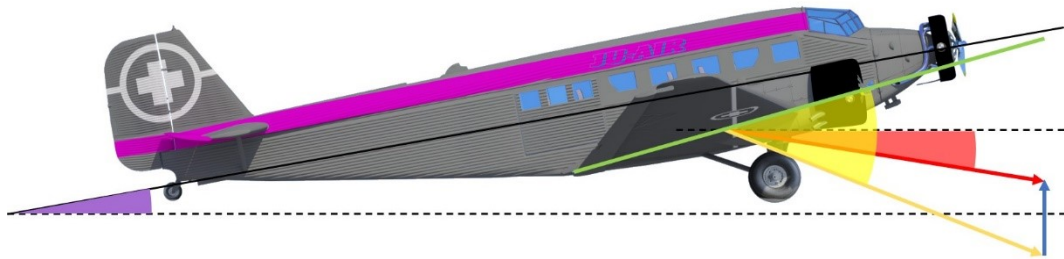
Figure 23: Entry into an area of updraught from an area of downdraught. The flight path vector (red) momentarily remains the same because of the inertia of the aircraft; Blue vector: updraught; Yellow vector: vector of movement for the aircraft in relation to the area of updraught. The angle of attack (yellow) increases considerably. Black line: longitudinal axis of the aircraft; Black dashed line: horizontal plane; Green line: chord line; Purple angle: pitch angle (angle between the horizontal plane and the aircraft's longitudinal axis); Red angle: flight path angle (angle between the horizontal plane and the flight path); Yellow angle: angle of attack (angle between the direction of airflow, which is the inverse of the vector of movement for the aircraft in relation to the area of updraught, and the chord line).
