Final Report No. 2370

by the Swiss Transportation Safety Investigation Board STSB

on the accident involving
the Junkers Ju 52/3m g4e
commercial aircraft, HB-HOT,

on 4 August 2018

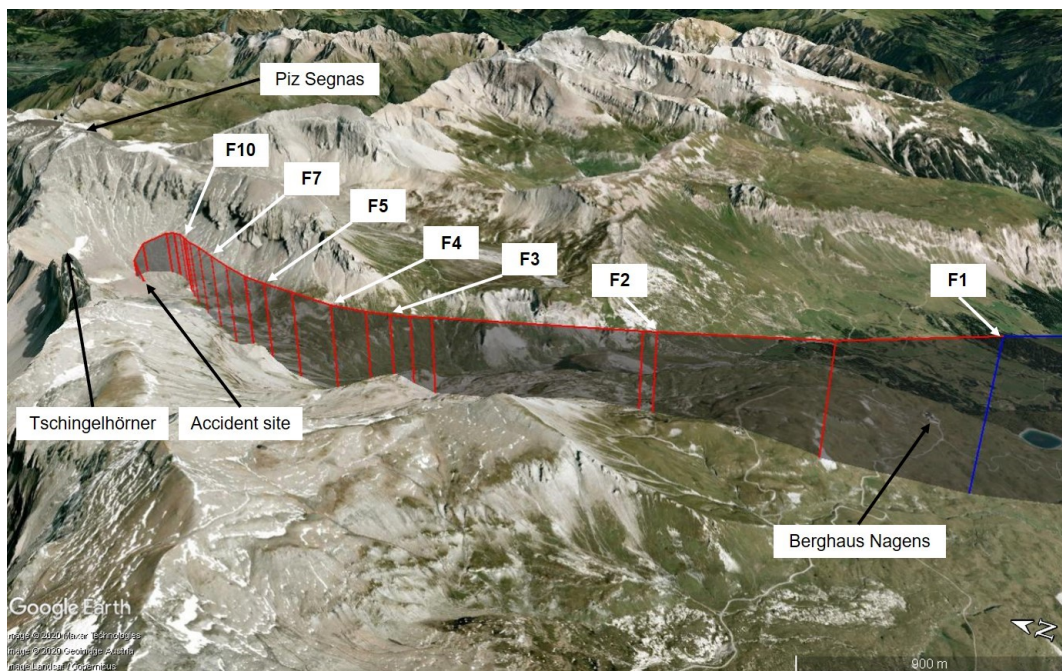
Figure 2: Reconstructed flight path of HB-HOT (red) from the Berghaus Nagens lodge to the site of the accident on 4 August 2018, shown on Google Earth. Point F1 is the first of a total of 29 points determined through photogrammetry. The flight altitude at point F1 was 2,833 m AMSL.

Towards point F3, the aircraft's altitude dropped slightly and the ground speed briefly increased by around 65 km/h to approximately 200 km/h. During this time, its pitch attitude³ was 5 to 7 degrees. Towards the end of this phase, just before point F4, the flight path angle⁴ changed from -3 degrees to approximately -1 degree and the speed of each of the three engines decreased steadily by approximately 20 revolutions per minute (rpm). At point F4, the aircraft was at an altitude of 2,742 m AMSL.

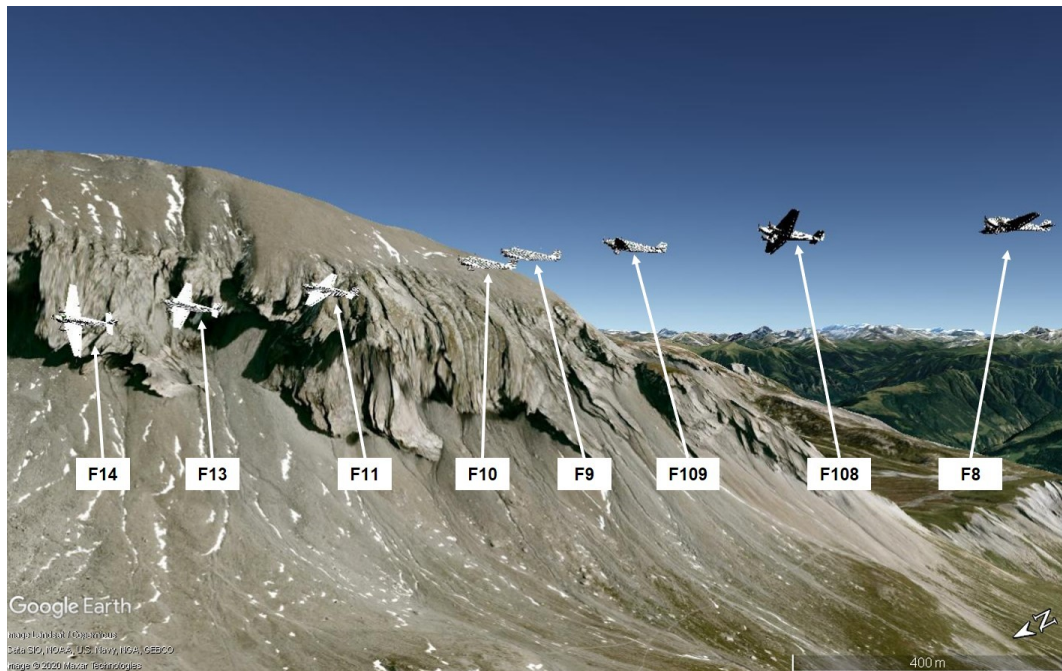
When the aircraft was approximately abeam the Martinsloch and at an altitude of approximately 2,766 m AMSL (point F8), the flight crew initiated a right turn during their descent and then made a left turn (point F109, see figure 5). The ground speed was approximately 170 km/h and the difference between the aircraft's pitch and flight path angles increased to approximately 15 degrees during the right turn. When transitioning into the left turn (between points F9 and F10), the pitch angle was approximately 11 degrees and the flight path angle was around -10 degrees. At this time, the aircraft was flying at approximately 125 m above the elevation of the Segnes pass (see figure 3).

During roughly the next 4 seconds, the aircraft descended by 25 m and the already negative flight path angle became even more negative, which is clearly apparent when comparing figures 3 and 4 as well as in figure 5.

Figure 5: Photogrammetrically reconstructed flight attitude at example positions, shown on Google Earth. The aircraft has been enlarged by a factor of 2 to make it easier to see.

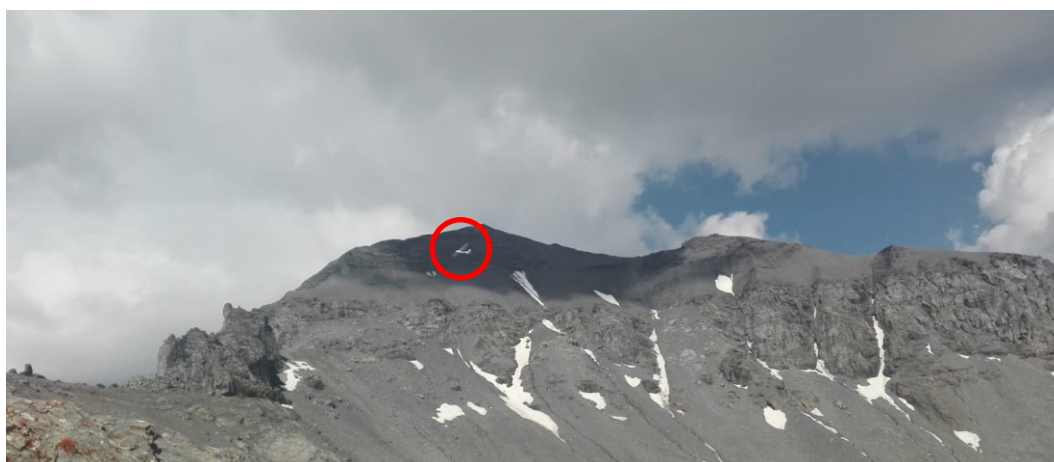
At 16:55 on 4 August 2018 – immediately before the accident involving HB-HOT – a single-engine, two-seater Cessna 152 aeroplane flew over the Segnes pass from the south. A trainee pilot on an alpine familiarisation flight and their flight instructor were on board. The aircraft encountered areas of downdraught in the Flims region and the crew decided to fly along the east side of the basin south-west of Piz Segnas, so that it would have been possible to turn back at any time even if the downdraught continued. At the selected altitude of 9,100 ft AMSL (2,800 m AMSL) the Cessna 152 flew into updraughts, which were interrupted again briefly by a weak area of downdraught just before the Segnes pass. The aircraft could cross the crest of the Segnes pass without any problems. No shear or turbulence was encountered at this altitude (see figure 10 and annex [A1.7](#)).

Figure 10: Photograph of the Cessna 152 (red circle) in front of Piz Segnas shortly before crossing the crest to the east of the Segnes pass with the aircraft flying west on 4 August 2018 at 16:55. The cloud over Piz Segnas is the same as that on the webcam images (see annex [A1.7](#)). Although it is not possible to ascertain the situation behind the pass based on this photo, the webcam footage from Elm as well as the flight instructor’s statement and figure 3 in this report indicate that there was good visibility above and behind the Segnes pass shortly before HB-HOT approached.

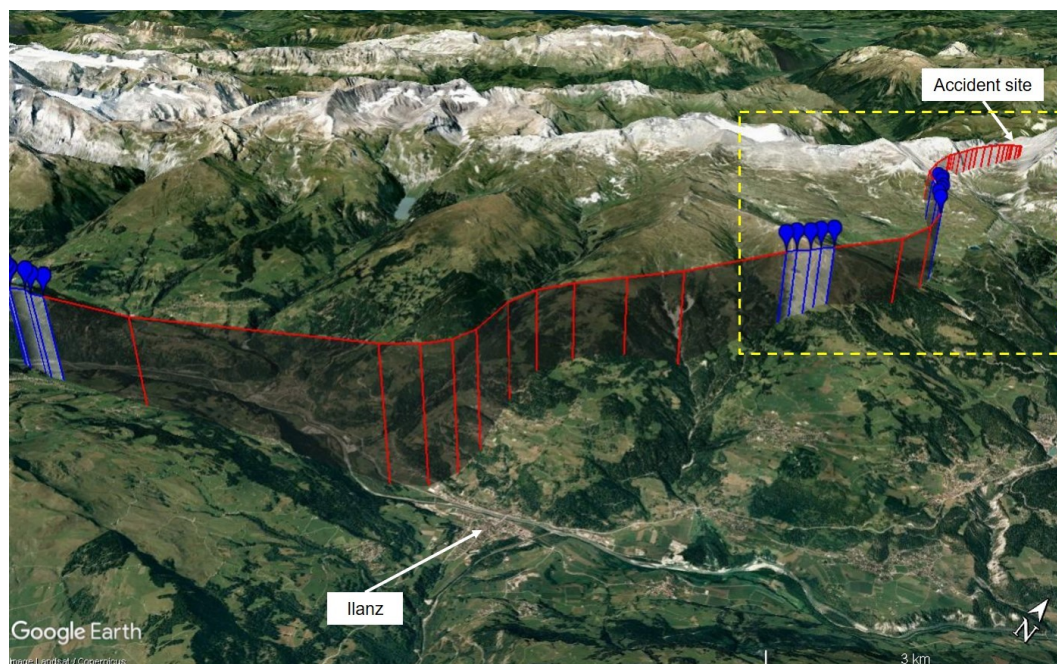
Based on the height-corrected MRT data points (blue dots in figures 11 and 12), HB-HOT flew past the mountain station on Crap Sogn Gion (2,215 m AMSL, see figure 12) at 16:54 on 4 August 2018. The aircraft had a flight altitude of approximately 2,740 m AMSL and was following a slight left turn. At the first photogrammetric point, F1²⁶, HB-HOT was at an altitude of 2,833 m AMSL on a true track (TT) of 335 degrees (see figure 12). The ground speed (GS) calculated by the MRT a few seconds before point F1 was 94 kt (corresponding to 48.4 m/s, or 174.1 km/h).

Figure 11: Reconstructed flight path of HB-HOT on 4 August 2018 near Ilanz (canton of Grisons) and leading up to the location of the accident with height-corrected MRT data points (blue), flight path sections reconstructed from witness statements and image material as well as photogrammetrically determined flight path sections (red), plotted on Google Earth. The area shown below in figure 12 is marked by the yellow dashed rectangle.

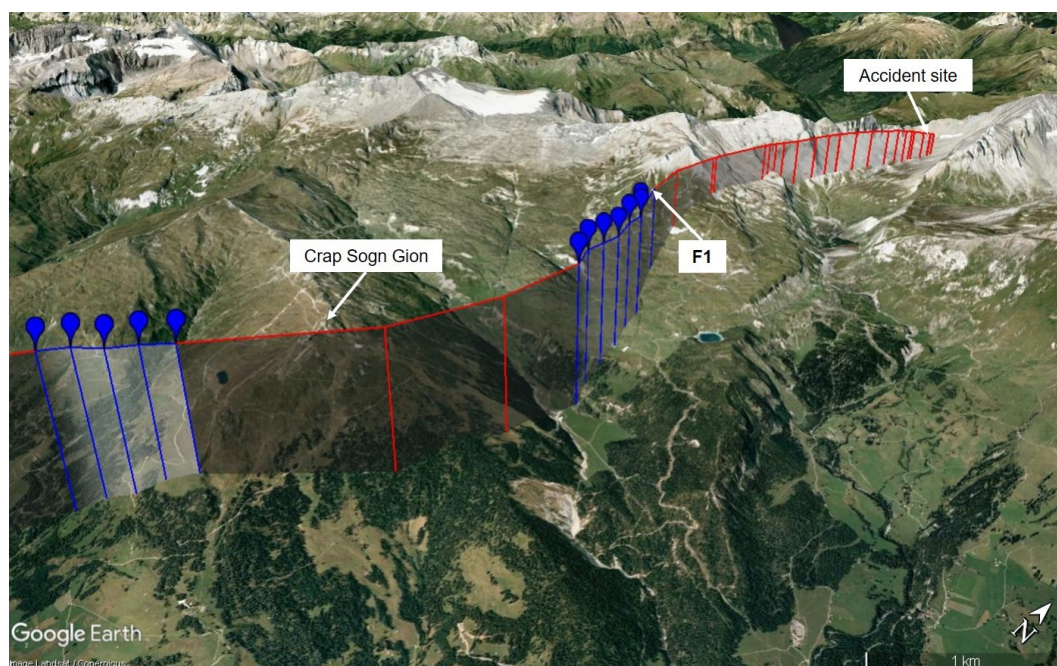
Figure 12: Reconstructed flight path of HB-HOT on 4 August 2018, shown on Google Earth. F1 denotes the first photogrammetrically determined point.

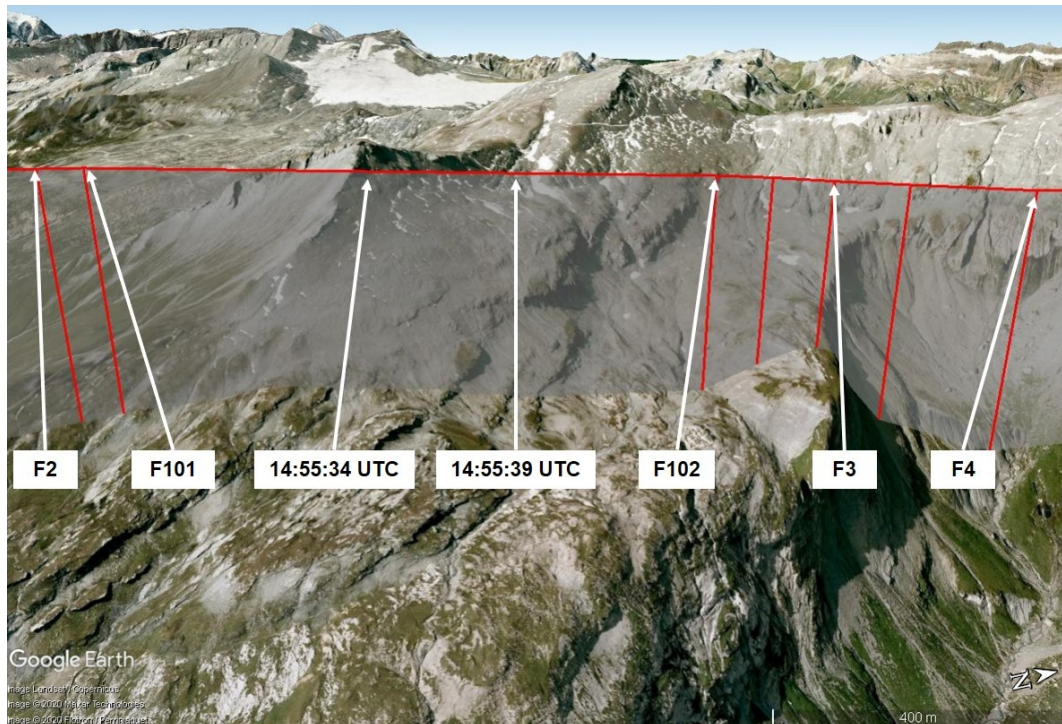
The first video recording ends shortly after point F101 and the second begins at point F102 (see figure 13).

During the gap in the recordings between points F101 and F102, radar data from HB-HOT's transponder were received. In addition to the usual data, on two occasions at known times, the mode-S transponder transmitted precise figures computed by the connected GPS device. This transmitted data included the true track (TT) and the GPS ground speed (GS). The relayed altitude was generated by the transponder's pressure probe. The GPS position itself was not transmitted. A radar station in a geometrically unfavourable location recorded the position of the aircraft when it transmitted these two data packets. However, the position could not be used as it was not sufficiently accurate. The transmitted values regarding time, TT and GS, on the other hand, are exact and were therefore used. Thus, two additional data packets containing time, TT and GS are available for this area:

- 14:55:34 UTC: TT = 353 degrees, GS = 74 kt (38.0 m/s or 137.0 km/h);
- 14:55:39 UTC: TT = 354 degrees, GS = 76 kt (39.1 m/s or 140.8 km/h).

Figure 13: Photogrammetrically reconstructed flight path of HB-HOT on 4 August 2018 (red) between points F2 and F4, shown on Google Earth. The two additional data packets at 14:55:34 UTC and 14:55:39 UTC were transmitted by the transponder.

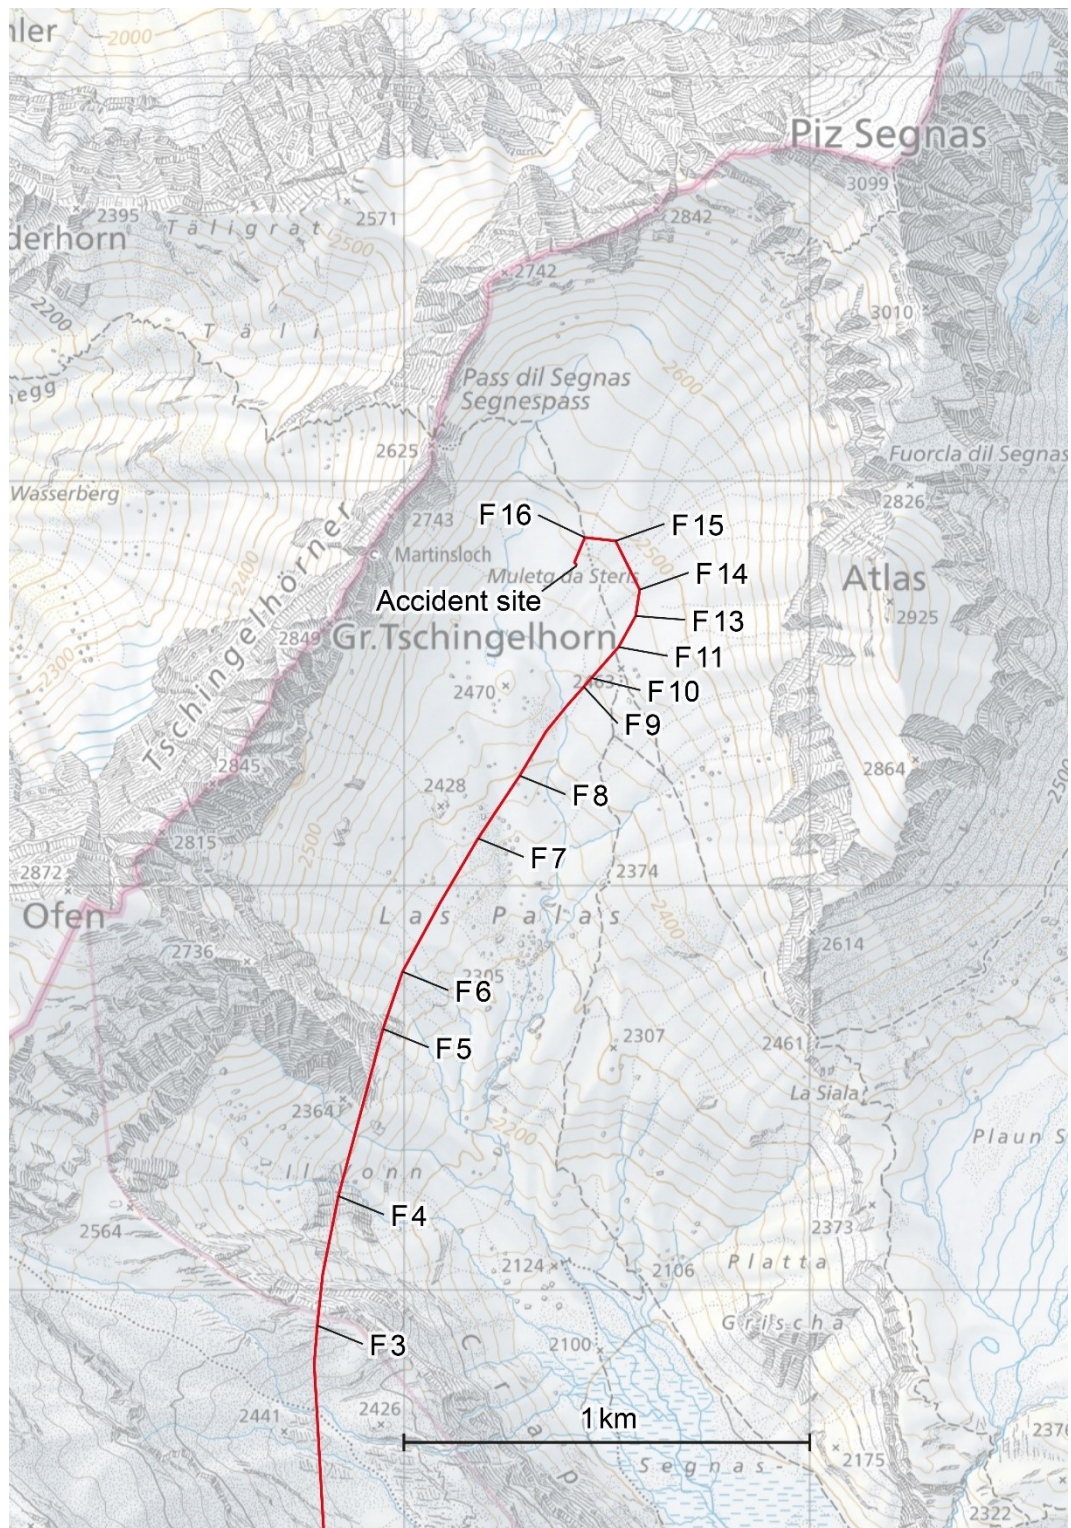
At 16:56:02, shortly after point F4, the speed of each of the three engines increased by approximately 40 rpm. At 16:56:09, HB-HOT entered the basin southwest of Piz Segnas at an altitude of 2,755 m AMSL (point F5, see also figure 14) and was therefore approximately 130 m above the elevation of the Segnes pass. The flight crew then navigated the aircraft on a north-north-easterly heading almost in the centre of the valley. HB-HOT climbed slightly during this phase and its flight path angle was approximately 2 degrees; its pitch angle remained at 5 to 7 degrees. At 16:56:17, the aircraft reached an altitude of 2,767 m AMSL at point F7 and was therefore approximately 140 m above the elevation of the Segnes pass.

Figure 14: Reconstructed flight path of HB-HOT on 4 August 2018 (red) between point F3 and the site of the accident. Source of the base map: Swiss Federal Office of Topography.

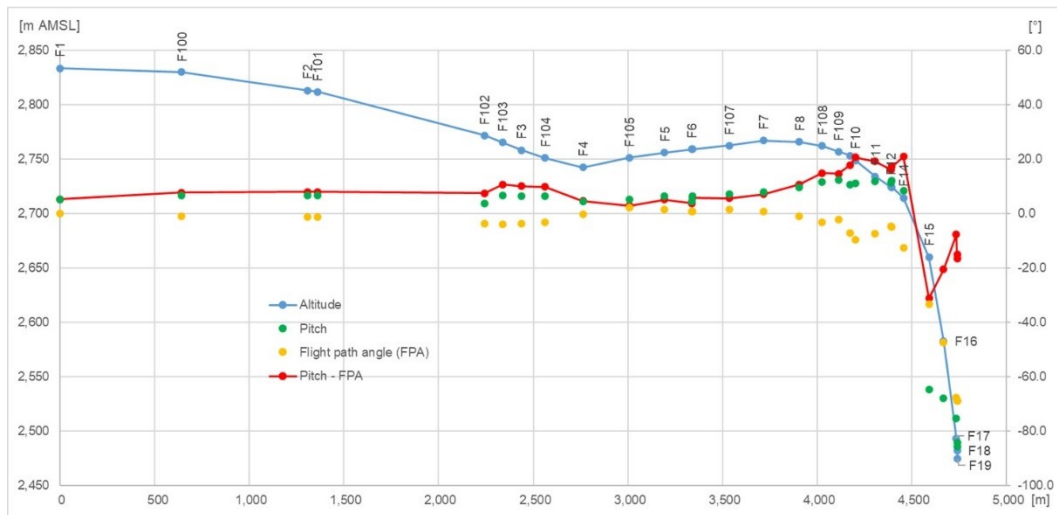
Figure 15 shows the altitude, pitch and flight path angles as well as the difference between these two angles.

Figure 15: Altitude, pitch and flight path angle (FPA) in relation to of the horizontal distance travelled. The left-hand y-axis shows the values for altitude and the right-hand y-axis shows the values for the angles.

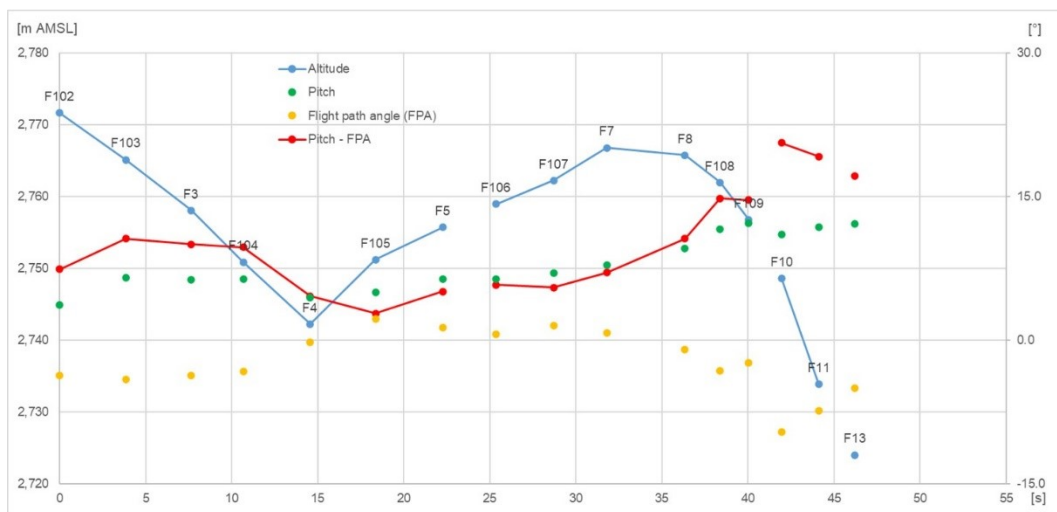
The parameters in figure 16 are shown in relation to the runtime of the video footage. F102 is the first point determined using this video. This is shown in figure 15 at a horizontal distance of 2,243 m. There are other points which have been determined from other data sources (e.g. F6 between points F5 and F106) between the unconnected points in figure 16. They are not illustrated as no runtime can be assigned to them.

Figure 16: Altitude, pitch and flight path angle in relation to the video runtime. The left-hand y-axis shows the values for altitude and the right-hand y-axis shows the values for the angles.

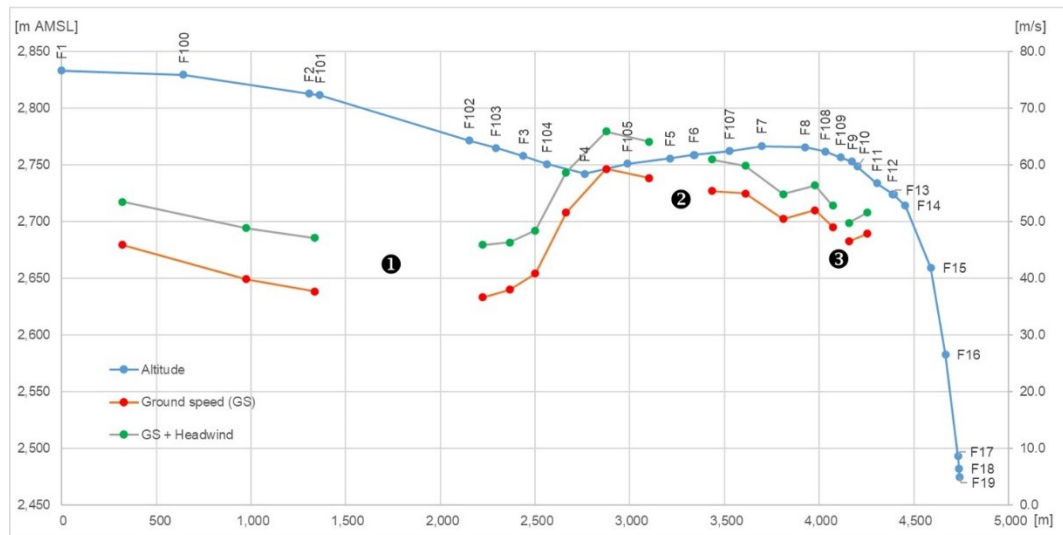
Figure 17 shows the calculated course of the ground speed (GS). The three values for the GS received from HB-HOT’s transponder were also considered.

Figure 17: Altitude, calculated ground speed and ground speed + headwind in relation to the accumulated horizontal distance.

In area ❶ (see figure 17) where the ground speed graph is interrupted, no time difference – and thus no ground speed – could be calculated, because the data points were determined using two different, unconnected videos. For the other gaps (areas ❷ and ❸), the points have been determined from other data sources. They are not shown as no runtime can be assigned to them.

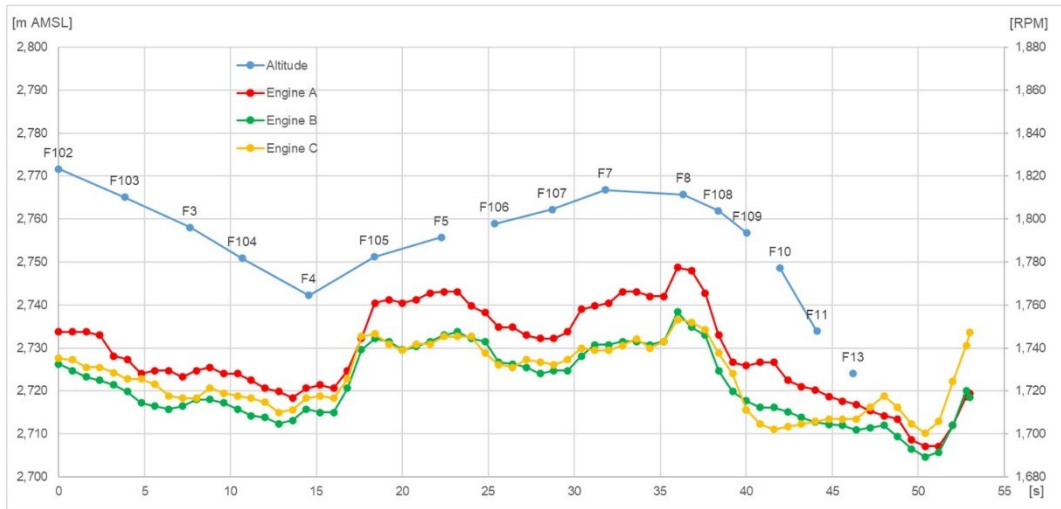
Figure 18 shows the course of the three engine speeds in relation to the video runtime. It was not possible to assign the speeds of engines A, B and C to the position of the engines (left, centre, right).

Figure 18: Altitude and engine speed in relation to the video runtime.

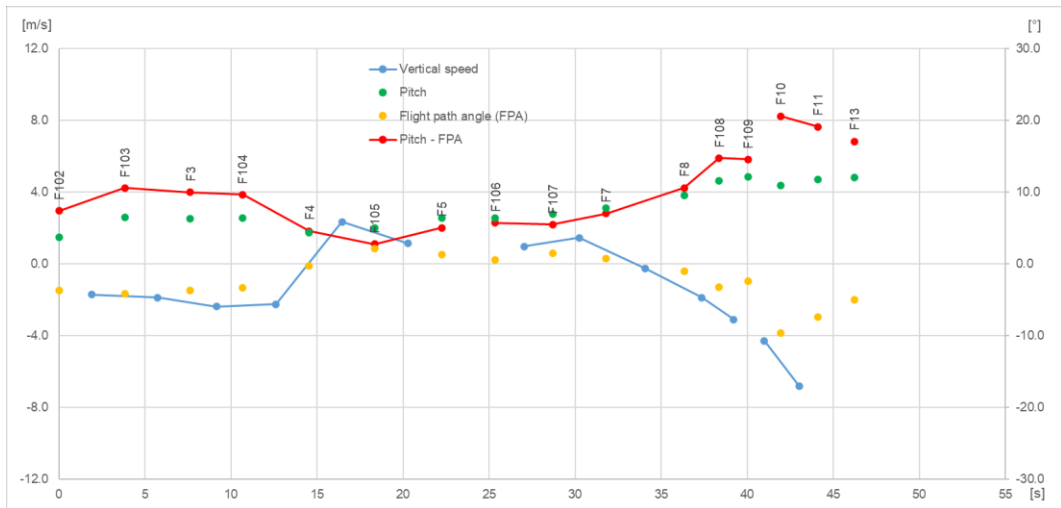
In addition to the pitch and FPA, figure 19 also shows the rate of ascent and descent in relation to the video runtime.

Figure 19: Vertical speed, pitch and flight path angle in relation to the video runtime.

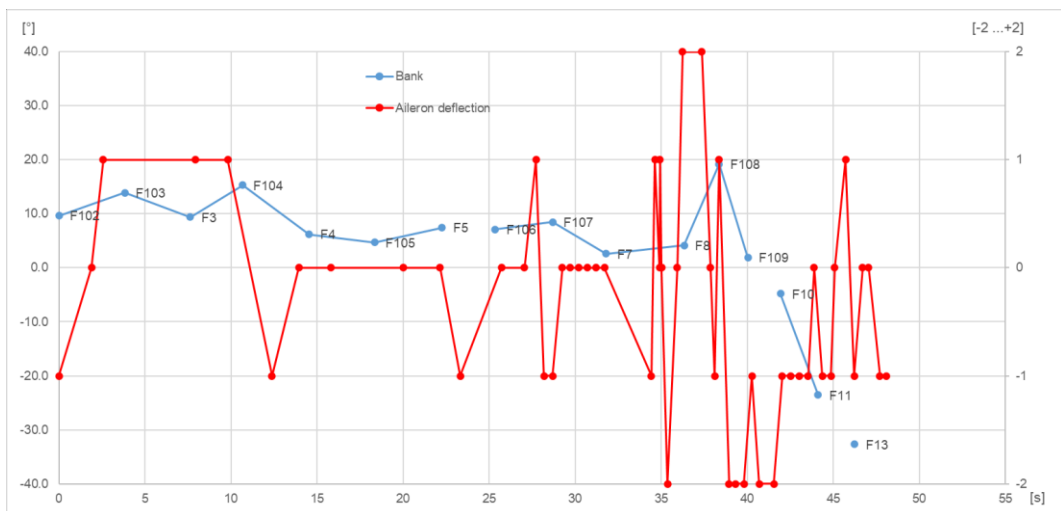
After point F13, the roll to the left increased steadily and did not decrease even when a significant aileron deflection to the right was made. The ailerons were then brought into a neutral position and temporarily deflected into a position for a left turn.

Figure 20: Bank and aileron deflection in relation to the video runtime. Positive values on the y-axis indicate bank to the right and aileron deflections for a right turn respectively. The bank angles were determined photogrammetrically.

The aileron deflections were qualitatively evaluated with values of - 2, - 1, 0, + 1 and + 2 (figure 20, right-hand y-axis) based on a video recorded from inside the aircraft. Positive values indicate an aileron deflection for a clockwise roll as seen in the direction of flight, i.e. for a right turn, whilst negative values indicate an aileron deflection for a left turn and a value of zero means the aileron position was neutral.
